Manhole Inspection Summary

Manhole # S35C1_012MH

Location Address: **2525 insulator drive**

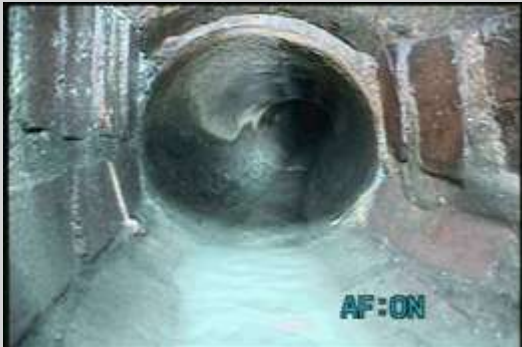
12 O'Clock Outflow

8 in. Circular Gravity Sewer
Pipe Out @ 12 O'Clock

Pipe Material: **Clay** ☐ Pipe Lined

Invert Depth: **5.33** (ft.) Flow Characteristics: **Fast**

Infiltration: **None** Pipe Seal Cond: **Unknown**

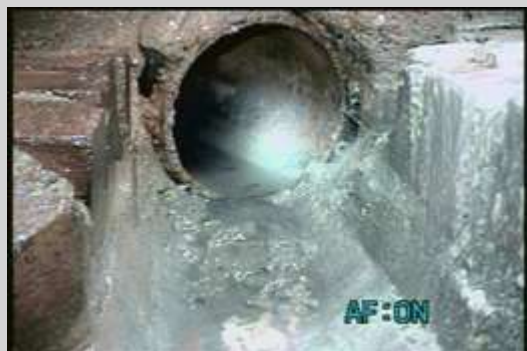
6 O'Clock Inflow

10 in. Circular Gravity Sewer
Pipe In @ 6 O'Clock

Pipe Material: **Clay** ☐ Pipe Lined

Infiltration: **None** Pipe Seal Cond: **Unknown**
